# Manhole Inspection Summary

Manhole # S21CC1054MH

**Location** Address: **1700 CLIPPER PARK RD** Cross Street: **UNION AVE**

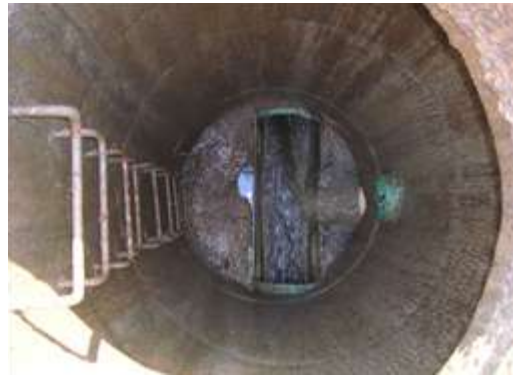
Top View

Bench debris.

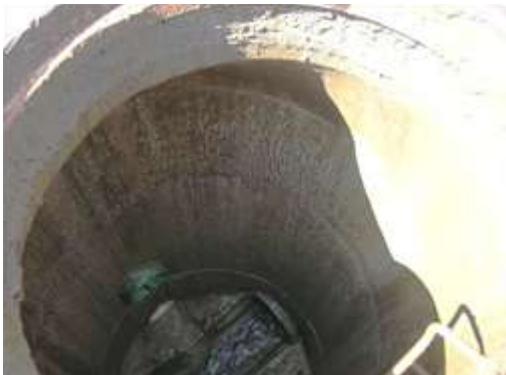
Defect

Frame leaks. Adjustment infiltration - other side.

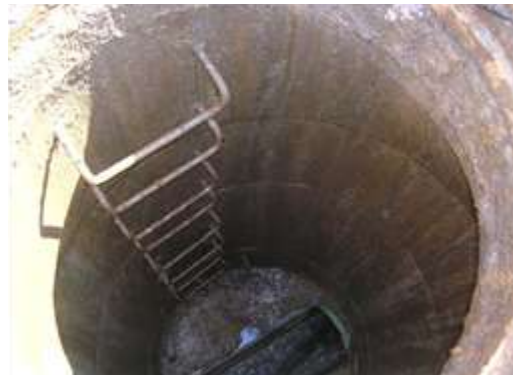
Defect

Frame leaks. Adjustment infiltration.

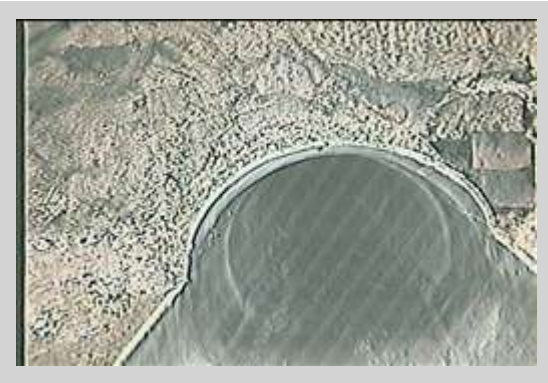
### 18 in. Circular Gravity Sewer Pipe Out @ 12 O'Clock

**Barrel** Material: **Brick and Concrete** ☐ Parged  
Shape: **Circular** Diameter: **48** (in.) Length: (in.)  
Condition: ☐ Sound ☐ Cracked ☐ Root Intrusion ☐ Loose Brick ☒ **Deteriorated**  
Infiltration: ☐ None ☐ Joint ☐ Cracks ☒ **Mortar** ☐ Roots ☐ Wall

Barrel deterioration and infiltration.

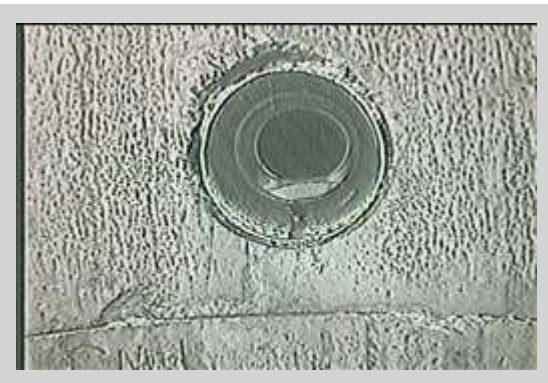
### 8 in. Circular Gravity Sewer Pipe In @ 3 O'Clock

Infiltration: **Evidence** Pipe Seal Cond: **Unknown**

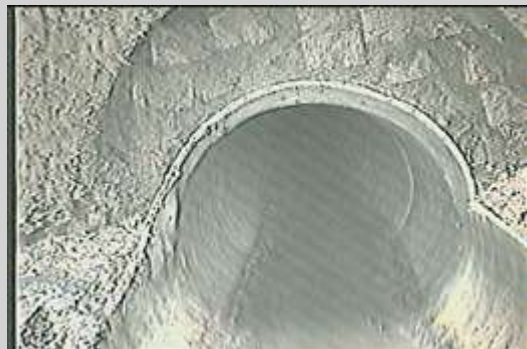
Pipe In @ 6 O'Clock

Infiltration: **Evidence**
